HOUSATONIC RIVER BASIN  
WASHINGTON, MASSACHUSETTS

WASHINGTON MOUNTAIN LAKE DIKE  
MA 00319

PHASE I INSPECTION REPORT  
NATIONAL DAM INSPECTION PROGRAM

DECEMBER 1979

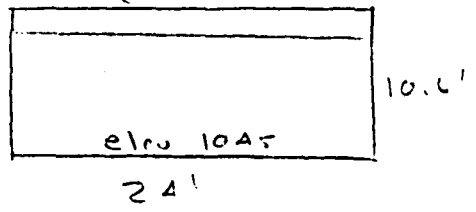
First Bridge Downstream on Washington R.R.

Red Flag - Good condition

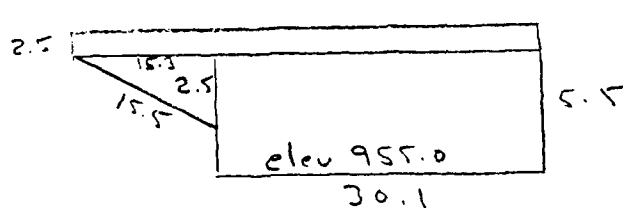
Flow Through Second Bridge Crossing

The second crossing can not handle the flow through due to failure. Therefore the bridge will be overtopped and the flow will be over the south side of the bridge.
